**Natural Resource Assessment  
18300 & 18450 NW West Union Road  
Portland, Oregon**

**PHS Project Number: 6689  
May 19, 2021 (Revised)**

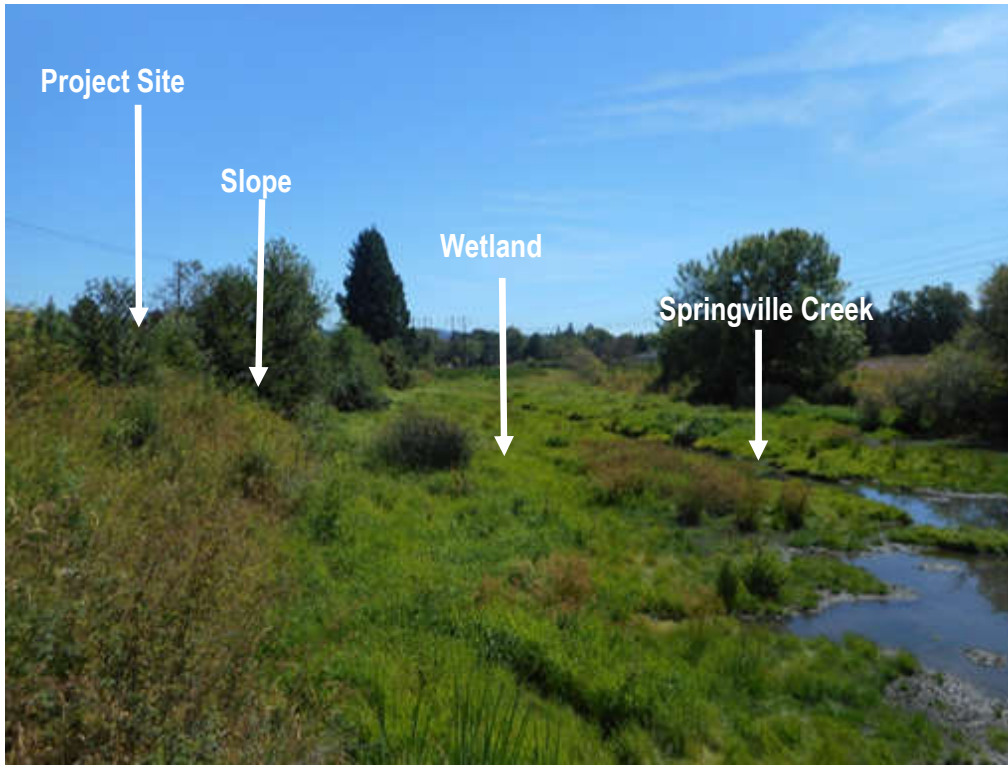
**Photo A**

Looking east at Springville Creek, adjacent wetland, slope along edge of wetland, and southern edge of project site.

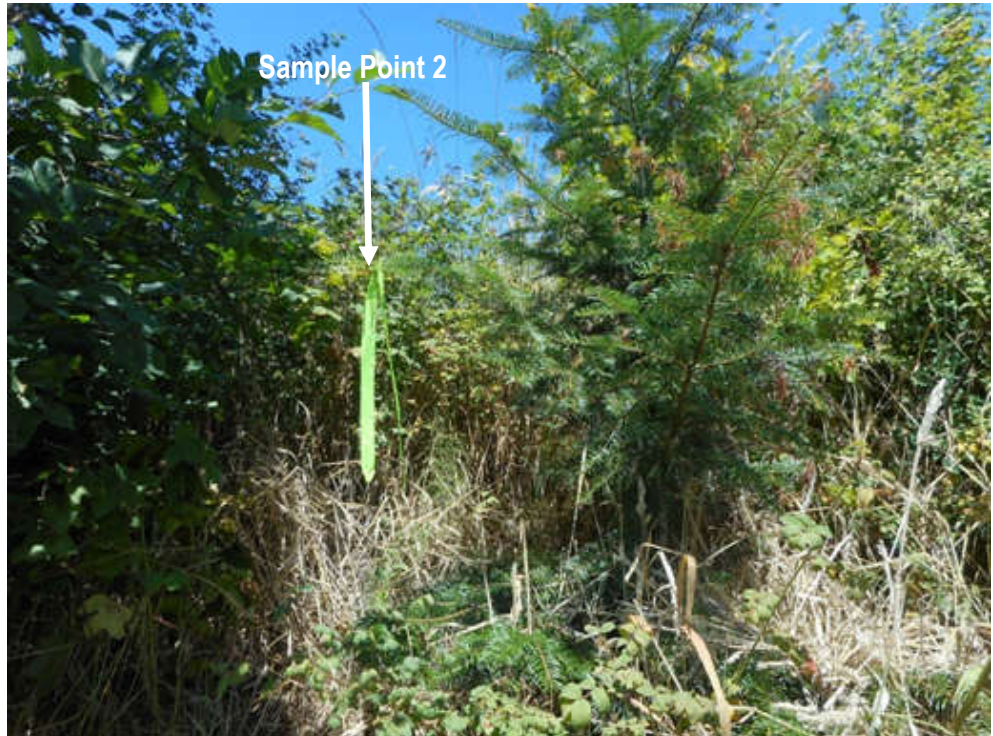
**Photo D**

Looking north at Sample Point 2.
